Manhole Inspection Summary

Manhole # S29S__008MH

Location Address: **Russell St.**

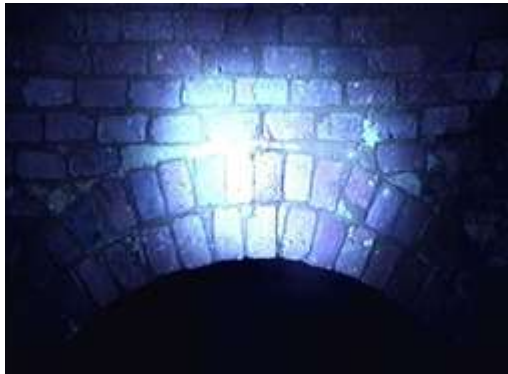
Defect 4

Condition: ☐ Sound ☒ Cracked ☐ Root Intrusion ☐ Loose Brick ☐ Deteriorated

cracked bricks barrel area above 6 oclk

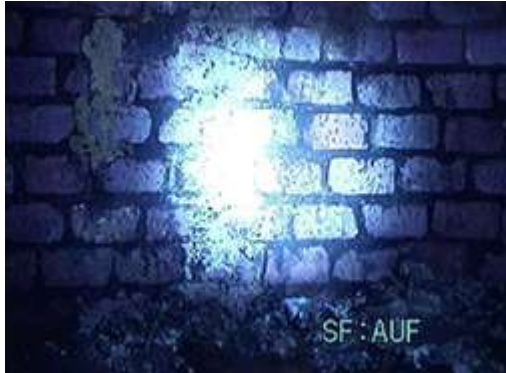
Defect 4

cracked bricks barrel area above 6 o'clock

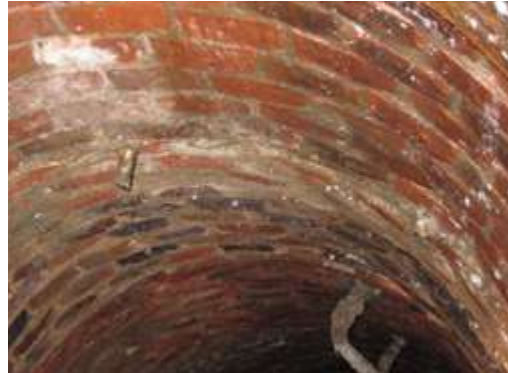
Defect 3

Infiltration: ☐ None ☐ Joint ☐ Cracks ☐ Mortar ☐ Roots ☒ Wall

Steps Count: **9** Missing: **1** ☒ Corroded

signs of corbel infiltration, missing step

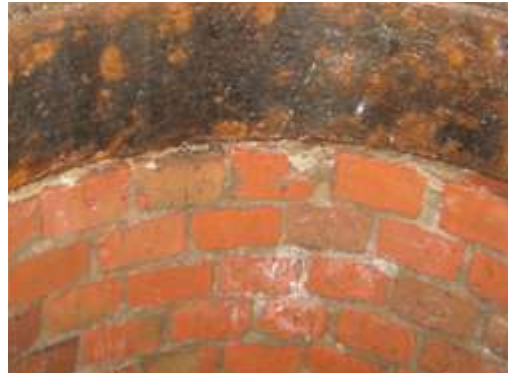
Defect 1

Infiltration: ☐ None ☐ Joint ☐ Cracks ☒ Mortar ☐ Roots ☐ Wall

missing mortar at chimney and frame joint with infiltration

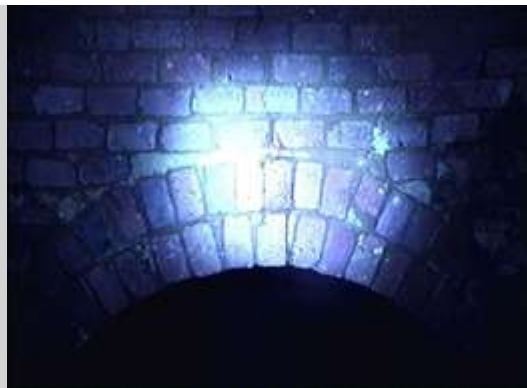
6 O'Clock Inflow

above 6 oclck cracked brick leading up to barrel
